TEST REPORT

BM8080 EN124 B125 Cover Test BIF - 14823

Date: 07/08/14

Client: Structural Science Composites Ltd.

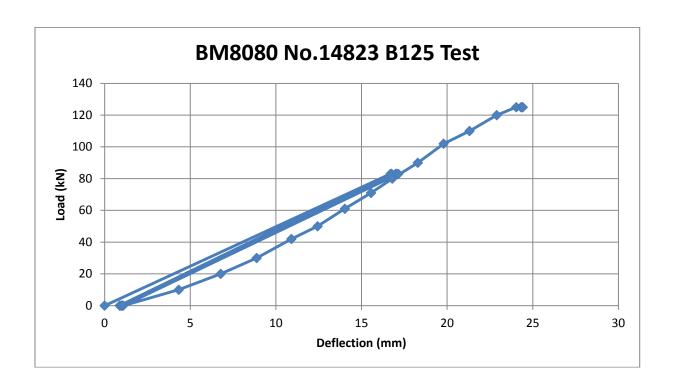
In accordance with EN124 Clause 8.3.1 the permanent set of the cover was 1.08mm which is within the permissible stated in Table 8 of the standard. $(1/100 \times 800 = 8.00mm)$.

The cover was then unloaded and inspected for damage where there was none found. (Photos.5 and 6)

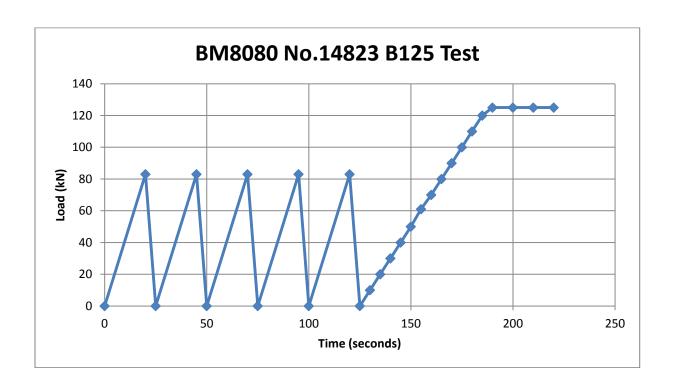
The frame showed no signs of any damage.
