TEST REPORT

BM3030 Composite Cover & Steel Frame EN124:2015 B125 Load Bearing Test (BIF 54337)

Document reference number - SSC-BM3030-LBT-54337-21-09-18

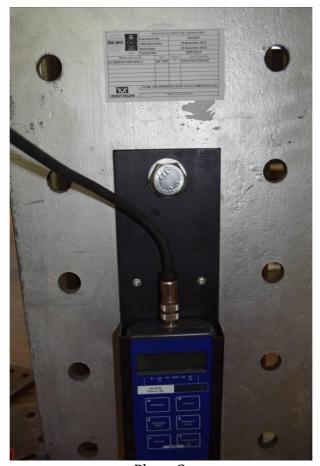
Photo.3

Calibration Sticker (Photo.3)

Test Rig ID: EG100TF Load Cell ID:

Instron Calibration Certificate No. E225112816155035

System Class: 2

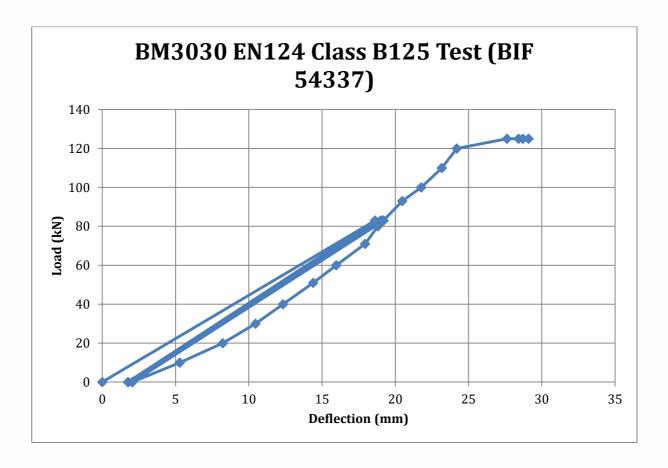
Although the standard does not require it for the load bearing test, a measuring device (linear potentiometer) was placed on the underside of the cover directly under the loading point. Deflection readings were taken throughout the test including the initial permanent set test and the results given in the following table.

LOAD (kN)	DEFLECTION (mm)	REMARKS
0	0.00	
83	18.62	
0	1.76	
83	19.00	
0	1.76	
83	19.20	
0	2.05	
83	19.20	
0	2.05	
83	19.11	
0	2.05	
10	5.29	
20	8.23	
30	10.46	
40	12.34	
51	14.40	
60	15.97	
71	17.94	
80	18.81	
93	20.48	
100	21.77	
110	23.18	
120	24.20	
125	27.63	
125 (10 seconds)	28.42	
125 (20 seconds)	28.71	
125 (30 seconds)	29.10	
0	4.50	PASS
165	Gauge removed	Ultimate failure

The deflection measurements taken above may not be totally accurate as some of the movement may be the wooden support frame crushing.

The cover held the test load for the required 30 seconds with no visible signs of damage.

The cover therefore passed the Load Bearing test.

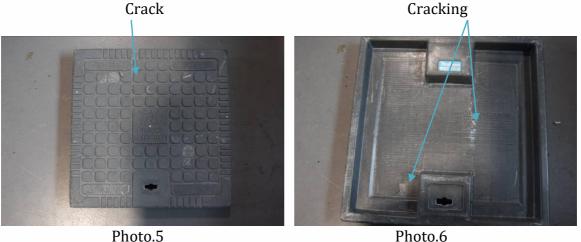
After the cover had passed the Load bearing test the linear potentiometer was removed from the underside to avoid any damage and the cover reloaded up to ultimate failure, which occurred at 165kN.

After failure the cover was removed from the test rig and inspected for damage. There was a large crack on the top face (photo.5) and some cracking to the underside (photo.6)
